# BELZONA REFURBISHES SETTLEMENT TANK AT WATER TREATMENT PLANT

Damaged Primary Settlement Tank (PST) at water authority site

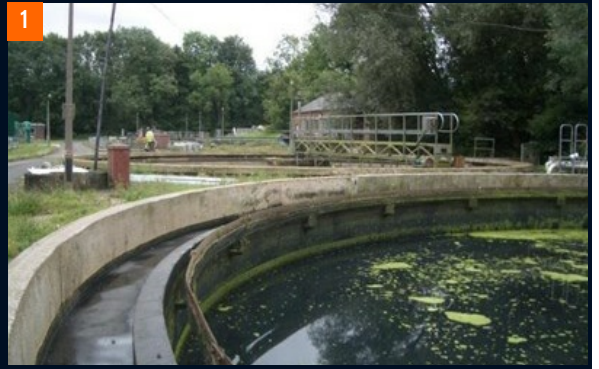
Due to freeze thaw damage and the constant weight of the separator arm, many areas of the running track had become damaged.

1. General view of the PST
2. Forming boards being used during application of the Belzona 4131
3. Expansion joint sealed with Belzona 2211
4. Completed repair
