# BELZONA CREATES RUBBER LOBES ON THIS ROTARY PUMP

ID: 357

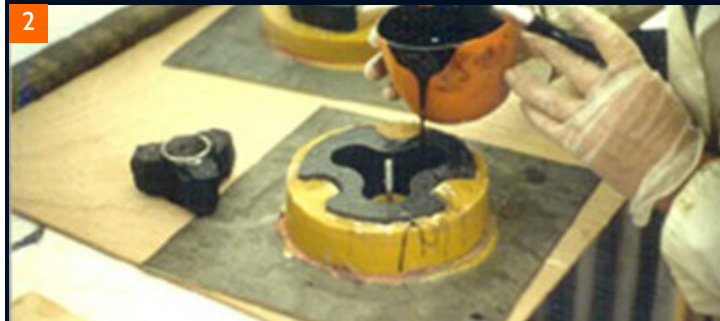
1. Mold prepared from new lobe
2. Pouring Belzona 2131 (D&A Fluid Elastomer) to fill the mold
3. Pair of lobes assembled in pump case housing
