# BELZONA ELIMINATES DAMAGE FROM CUI (CORROSION UNDER INSULATION)

ID: 358

The vessel was suffering from CUI (Corrosion Under Insulation).

Outdoor condensate vessel.

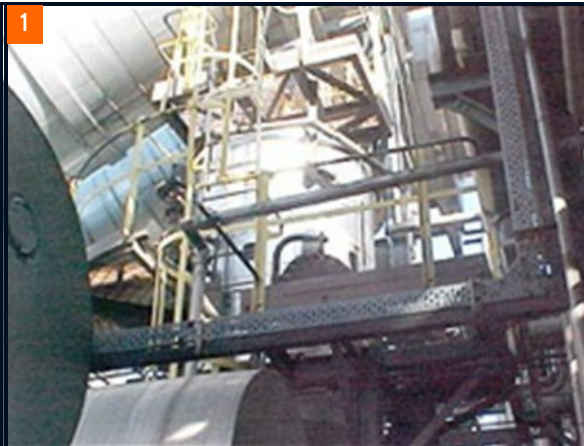
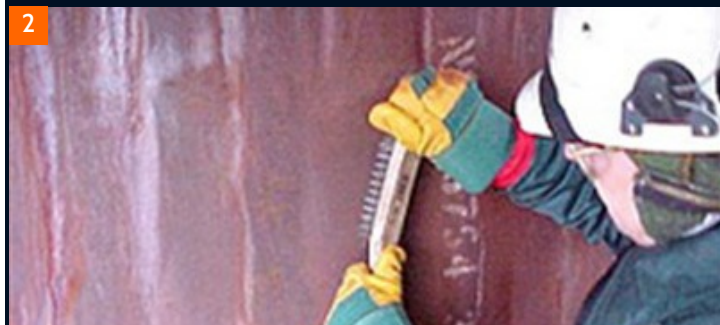
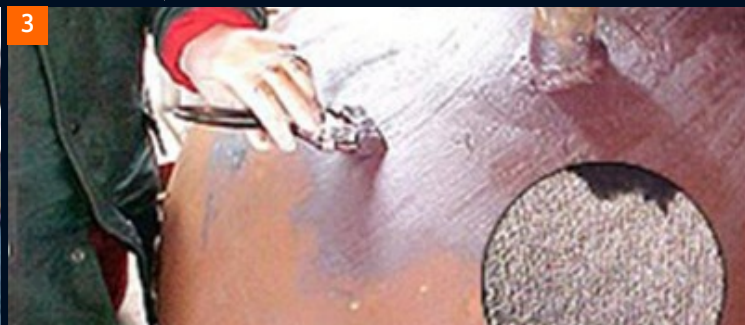
An overall view of the vessel, complete with lagging, while in service. Surface preparation was carried out via wire brush and power wire-brushing tool. Belzona 5851 is being applied via brush. Close-up of application area. Showing brush strokes after one year of service.

The surface was prepared manually with a wire brush and a power wire brushing tool was used to remove loose particles. Belzona® 5851 was applied by brush. Once the material cured, the vessel was re-lagged.

Belzona® 5851 is heat activated (begins to cure at temperatures of 70°C or higher) and can be used on equipment that is in service making downtime a thing of the past. The application was last inspected in 2008 and the plant engineers found the Belzona® 5851 still to be providing excellent corrosion protection.
