# BELZONA PROTECTS FRACTIONATOR TOWER

ID: 359

Fractionator tower in cracker unit.

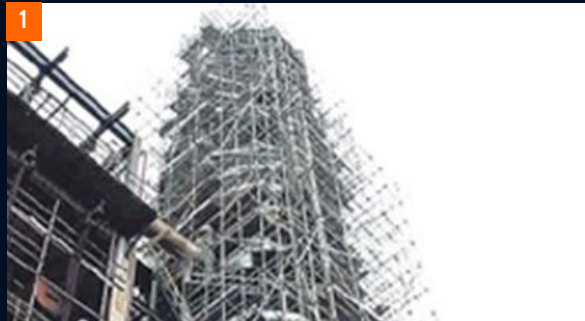
General view of the tower. The degree of corrosion clearly evident on the support rings. Application underway. Application complete.

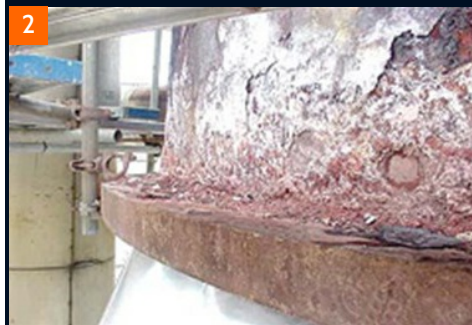
CUI (Corrosion Under Insulation) particularly around the support rings where moisture had accumulated.
