# BELZONA TANK FARM

Chemical containment area (5000 sq. ft.)

Chemical Plant in South Alabama, USA

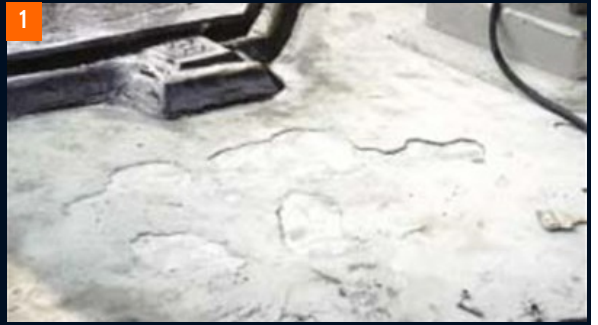
Harsh chemicals attacking existing substrate which was installed in 1993.

The previous polymeric concrete repair material was damaged by chemical attack. The concrete was repaired and all areas protected.

1. View of damage to polymeric repair compound
2. Application of Belzona 4311 (Magma CR-1) in progress
3. 5000 sq. ft. area protected
