# BELZONA GETS THE NOD WHEN DOWNTIME MUST BE MINIMIZED

ID: 360

Anchor casing

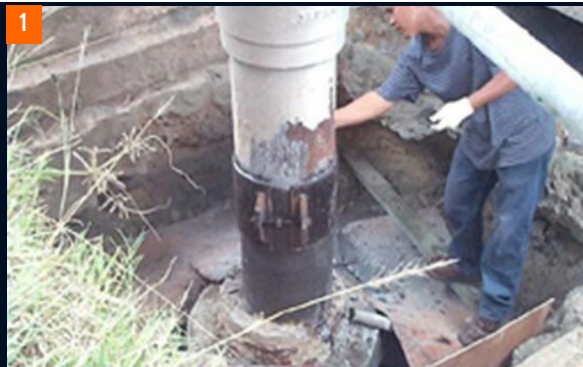
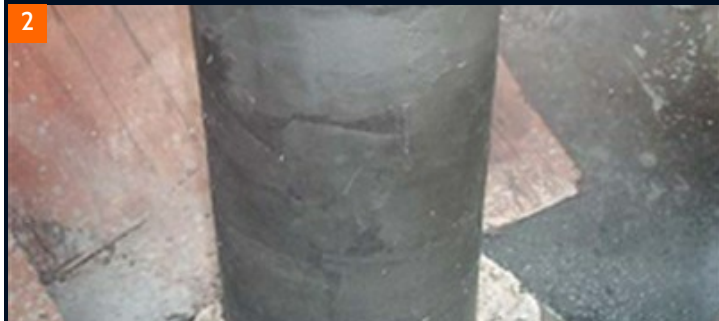
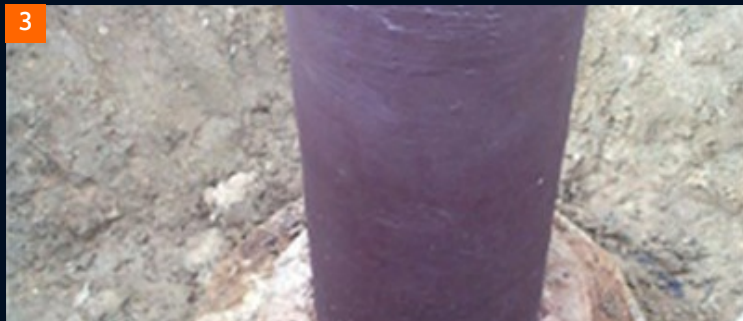
This anchor casing was badly in need of repair. Plant engineers did not want to shut down the equipment, leaving Belzona's heat-activated products as the only viable option.

Pitted areas are rebuilt with Belzona 1251 prior to Belzona 5851 application. Belzona 1251 is heat cured in service with adhesion strength of 3200 psi. Final coat of Belzona 5851 for extra protection.

Manual surface preparation was used. Next, a new metal jacket was placed over the heavily pitted areas and bonded in place with Belzona® 1251. After the material began to cure, Belzona® 5851 was used to coat the entire area for extra protection.
