# CORRODED PIPEWORK: A THING OF THE PAST WITH BELZONA 5851 (HA-BARRIER)

ID: 361

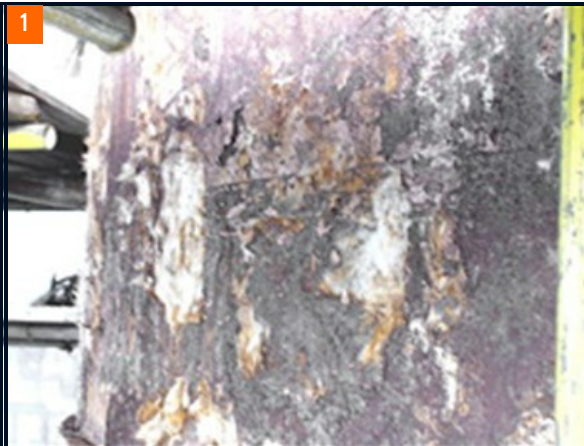
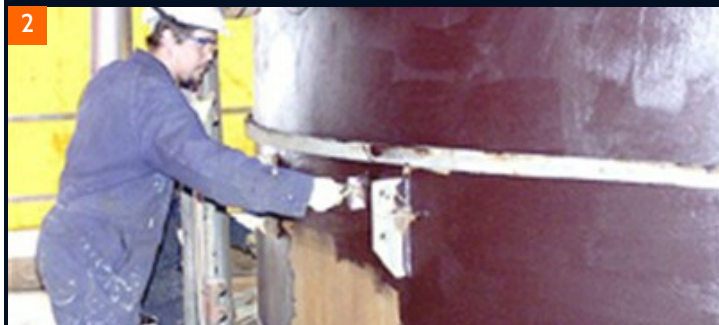
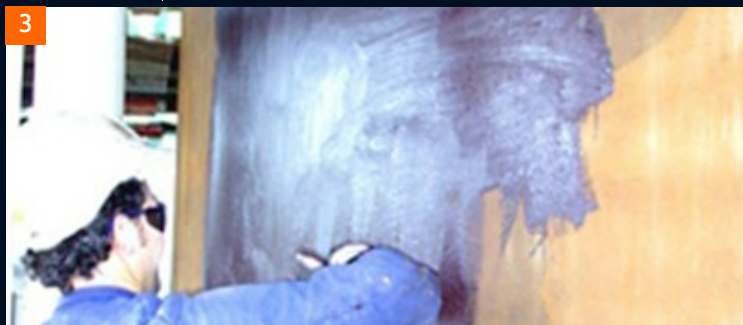
CUI (Corrosion Under Insulation) was causing costly shutdowns to under-take repairs.

Corroded pipework and columns.

Prior to application, corrosion can easily be seen. Belzona 5851 (HA-Barrier) is easily applied to hot surfaces by trower, brush, or even spray.

Manual surface preparation was done with high pressure water blasting. Belzona® 5851 (HA-Barrier) was applied directly to hot pipework while in service.
