# COLD BONDING WITH BELZONA OFFERED ALTERNATIVE REPAIR TO PENSTOCK

ID: 3617

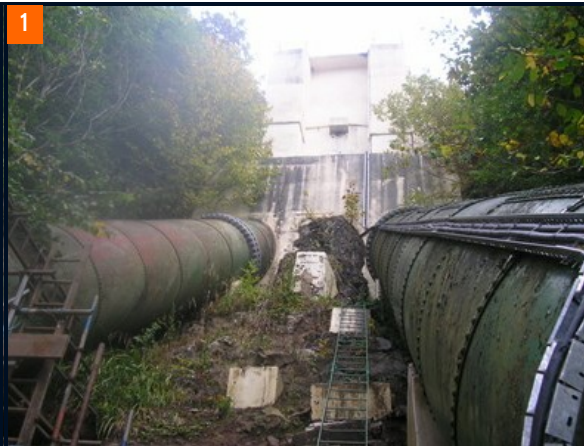
The penstock had been weld repaired and due to the nature of hot works, the penstock had deformed and created a void between the penstock pipe and the concrete support pad. The Hydro power station would not accept the void between penstock and the pipe support and informed the contractor they would need to rectify the problem before signing the job off.

1. View of the penstock
2. View of the pipe support
3. Brass plate being put into place
3. Application completed (Belzona 1211 on the edges, Belzona 5811 injected in the void)
