# BELZONA LEADING EDGE SOLUTION FOR WICKET GATES

ID: 3618

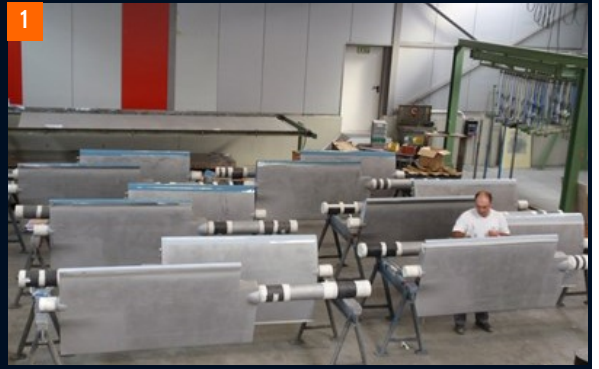
1. View of the wicket gates after blasting
2. Belzona 1341 applied to offer erosion corrosion protection
3. Belzona 2121 applied to offer impact resistance
4. View of the wicket gates completed

Application was carried out in accordance with Belzona Know-How System Leaflet CEP-3. Belzona® 1341 was applied to offer resistance to erosion corrosion. As the leading edges are known to suffer from impact damage due to solids in the water, Belzona® 2121 was applied in two coats (red and black) to offer impact protection in these specific areas.
