# CAR PARK REPAIRS WITH BELZONA

ID: 3619

Ceilings and walls in council car park

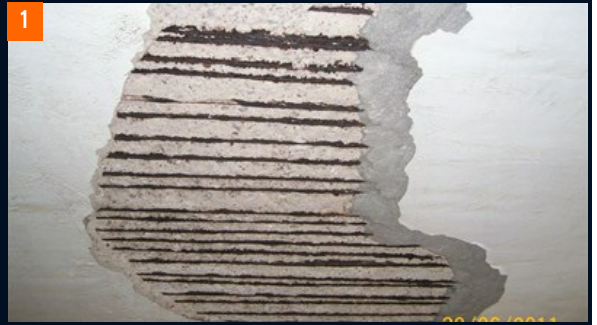
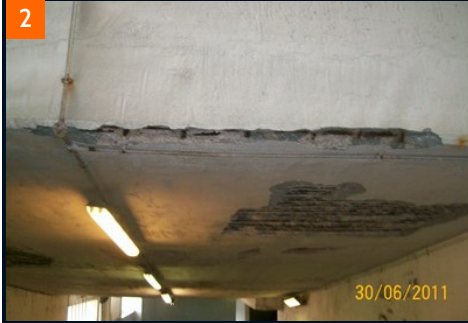
Carbonation of the reinforced concrete had led to extensive spalling on ceilings and walls, which required urgent repair.

1 & 2. Severe spalling on ceilings

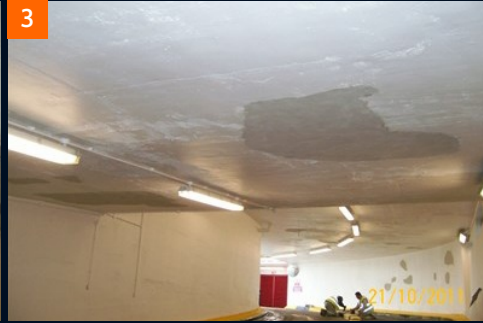
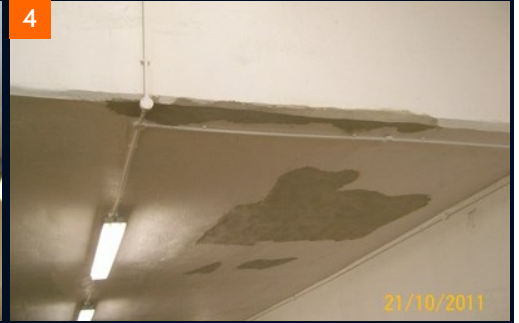
3 & 4. After: Belzona 4141 applied to the overhead surfaces

The application was carried out in accordance with Belzona Know-How System Leaflet WPA-6.

The material's fast cure meant that the parking deck was reopened with minimum disruption and the repairs could be directly over-painted after just 3 days, which was the amount of time required to complete the concrete repair. The council selected Belzona as their first choice due to previous successful work undertaken for the council on another city car park.
