# BELZONA REPAIR AND PROTECTION OF HYDRO PLANT DRAFT TUBE

ID: 3634

Severe damage caused by cavitation in the upper part of the draft tube.

Hydroelectric power plant draft tube.

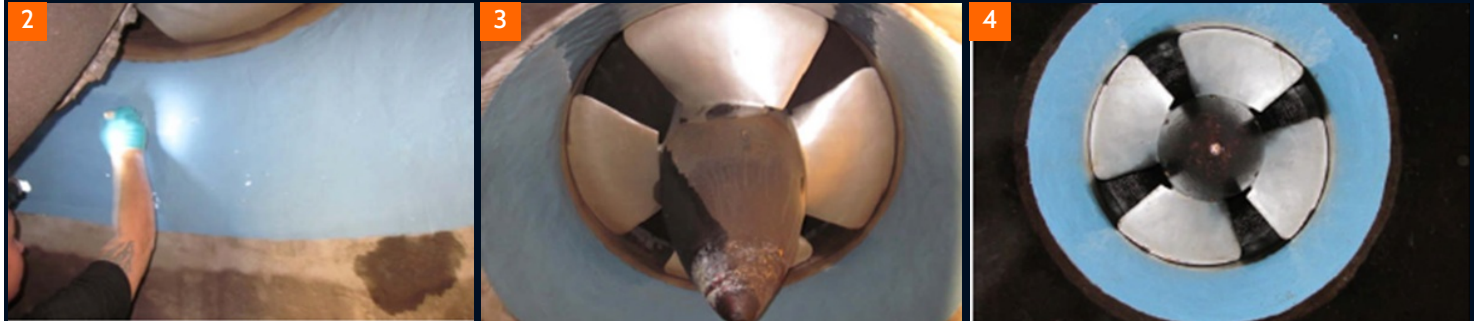
## PHOTOS

1. The draft tube being repaired with Belzona 4111
2. The repair area being coated with Belzona 1341
3. The finished application
4. The application one year later

Application was carried out in accordance with Belzona Know-How System Leaflet CEP-10. After drying and preparing substrate Belzona® 4111 was used to rebuild damaged concrete before coating with Belzona® 1341.
