# BELZONA REPAIRS FLOATING HOSES

ID: 3640

## PROBLEM

Dredger damage to the floating hoses.

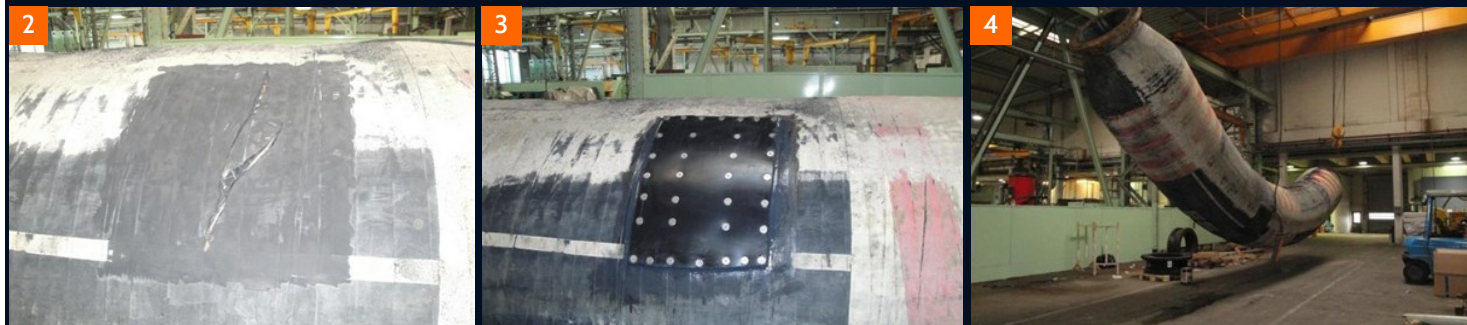
## PHOTOS

The floating hoses were in use at the port and were to be transported to Odessa, Ukraine, for another project. During dredging damage was caused to the outer skin. Only five days were available to repair 6 floating hoses, a replacement was not available. A new hose would have cost 60,000 EURO. In order to meet the strict deadline a specialist company was sought to undertake the repair and prevent future problems associated with the project. As a result of previous co-operation and many years of experience within the marine and dredging industry the Belzona distributor was recommended to undertake the repair. Following 24 hours after the repair comprehensive performance tests were undertaken; the Belzona repair passed successfully.

1. Close-up of damage
2. Surface preparation roughening
3. Completed application including use of stainless steel screws to hold the repair in place
4. Performance test (24 hours)

The repair was carried out using a modified version of SOS-12. Surface preparation consisted of roughening the surfaces prior to the application of Belzona® 2911. A rubber mat was bonded over the damaged area with Belzona® 2211, using stainless steel screws to hold the repair in place.
