# BELZONA REPAIRS BOW THRUSTER

ID: 3642

Bow thruster casing of a cargo ship.

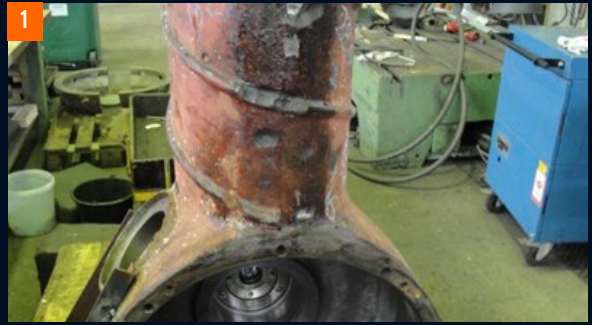
Extensive damage to the bevel gear system's casing.

1. Extensive damage clearly visible
2. Close-up following grit blasting
3. Application in progress
4. Completed application
