# BELZONA REPAIR & PROTECTION OF FRANCIS TURBINE RUNNERS

ID: 3645

Hydroelectric power plant, Barcelona, Spain

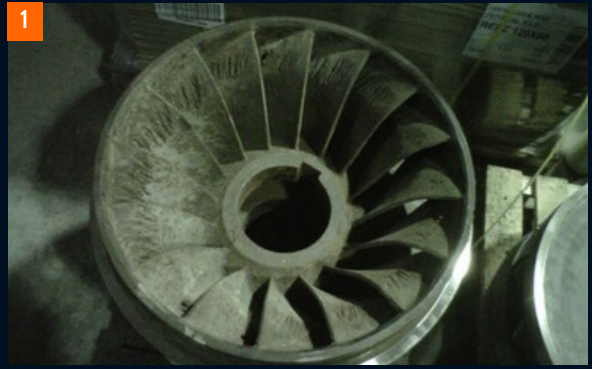
The turbines were suffering from corrosion and erosion cavitation damage in the runner blades which caused holes.

Damaged turbine Close-up of the damage Belzona 1111 used in combination with a metallic mesh Application completed with Belzona 1341
