# BELZONA PROTECTION TO AERZENER LOBE COMPRESSOR

ID: 365

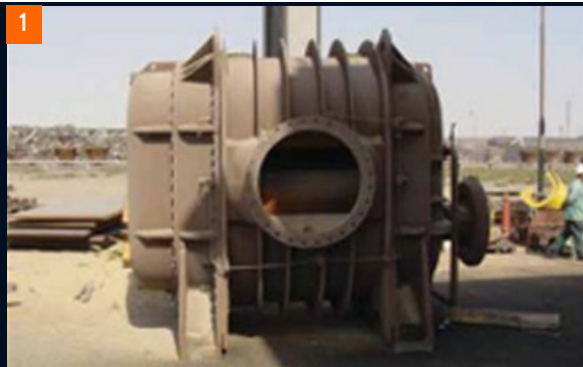
Hot scrubbed gas contains fine particles which are broken down by spraying with water, this combination causes severe corrosion.

1. General view of compressor
2. Work underway on the lobe
3. Body and lobe protected with Belzona 1391

Application was carried out using a modified version of Belzona System Leaflets PDP-4, FBC-2 and FBC-5. Pitting damage repaired with Belzona® 1111 and internal casing and lobe protected with Belzona® 1391.
