# BELZONA PREVENTS GALVANIC AND CREVICE CORROSION ON RUDDER HORN

ID: 367

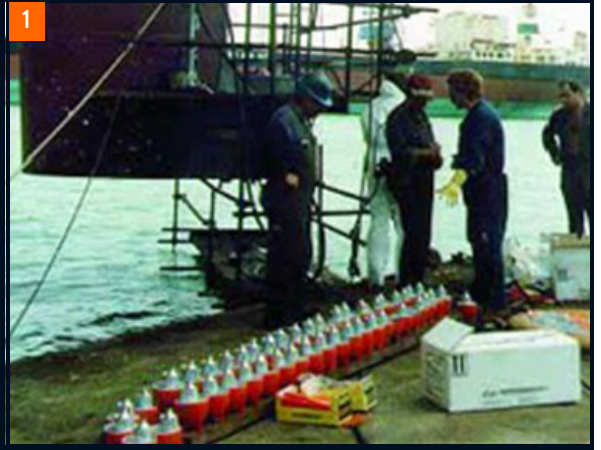
1. Belzona materials and team prepared for application.
2. Internal shot of bearing. Note arrows for injection ports.
3. Bearing after injection and prior to cleaning up of the Belzona 1211 seal.

The bearing was aligned and its position in the housing fixed using alignment bolts. The top and bottom of the housing were sealed using Belzona® 1211, then Belzona® 1321 was injected from below.

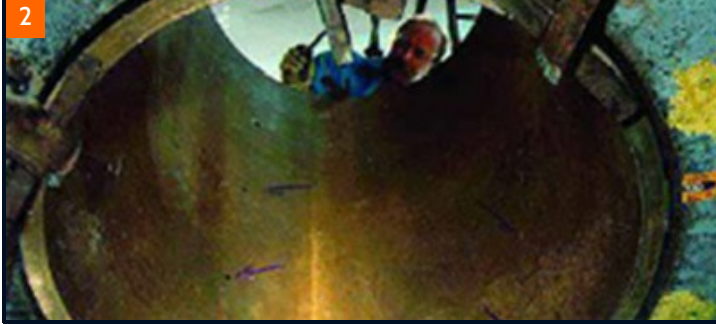
Corrosion to internal of rudder horn had allowed the press fitted bronze bearing to become free. Bearing was approximately 908-mm (36-inch) diameter and 1050-mm (41-inch) long.
