# CLASSIC TAIL SHAFT WRAP WITH BELZONA

Tail shaft for Fleet Auxiliary Ship (Landing Ship Logistics)

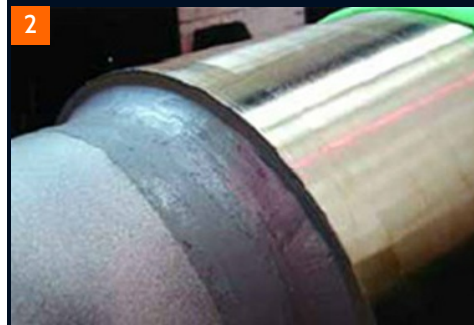
1. Shaft grit blasted and set up in lathe ready for start of application
2. Belzona 1111 used to create a chamfer to seal between the shaft and the liner.
3. First coat of Belzona 1321 applied incorporating Belzona 9341
4. Completed application after application of second coat of Belzona 1321.
