# BELZONA EMERGENCY IN A COOLING TOWER

## PROBLEM

Crack (leak) in the containment wall and floor.

Cooling tower containment

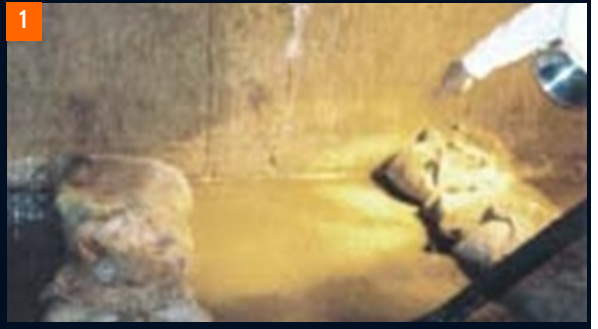
## PHOTOS

1. The leak; sand bags used to hold back as much water as possible
2. The completed repair

The application was carried out in accordance with a modified version of Belzona Know-How Leaflet TCC-1.

The repair was performed overnight and the plant was operational early the next morning. It is estimated that the plant saved \$6,000 in water cost alone.

Belzona 3121 (MR-7)
