# BELZONA EXPANSION JOINTS: TOUGH ENOUGH FOR HEAVILY TRAVELLED HIGHWAYS

ID: 371

Bridge expansion joints on Interstate 65.

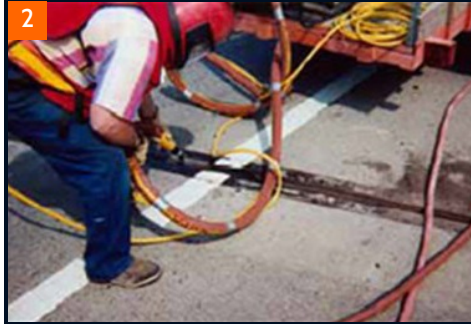
The conventional expansion joints were too soft and could not withstand typical road debris. They were failing after less than one year.

1. The failed joint is easily removed thanks to poor adhesion
2. The surface for the new joint is prepared
3. Backer rod inserted
4. The application is complete and ready for vehicular traffic

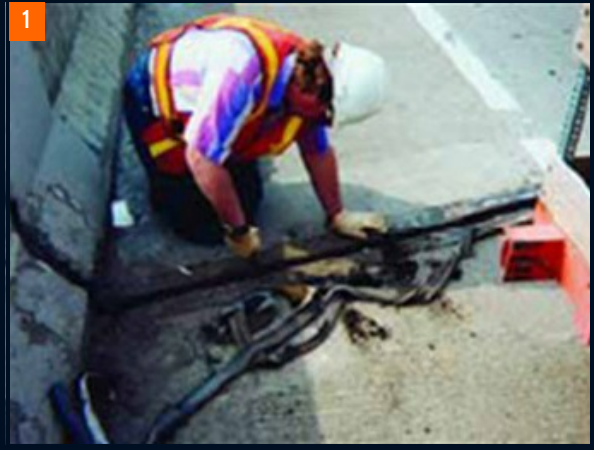
The failing conventional joints were also allowing solutions of calcium chloride and salt to seep through and damage the structural beams. The Belzona solution prevents this from occurring, and has performed perfectly since installation.
