# BIG SAVINGS WITH BELZONA'S UNCONVENTIONAL REPAIR TECHNIQUES

ID: 372

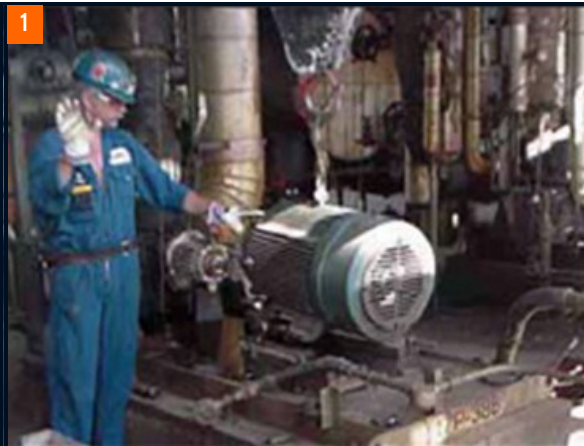
1. Removal of pump from base
2. Installing injection ports
3. Injecting with gun

The Application was carried out in accordance with a modified version of Belzona Know-How Systems leaflet GSS-9. Injection Method: Product placed in pneumatic gun, injected using static mixer.
