# BELZONA AIR HANDLING FAN & SHROUD

ID: 373

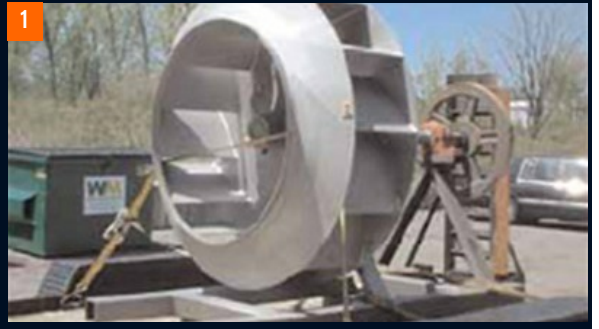
Fan was constantly going out of balance due to particulate sticking to the blade.

1. Fan blasted to 3-4 mil profile, white metal finish
2. Second coat of Belzona 1341 completed on fan
3. Shroud coat completed

The Application was carried out in accordance with Belzona Know-How System Leaflet FBC-2.

The fan was dynamically balanced before and after the application.
