# BELZONA EXCELS WHERE OTHERS FAIL!

ID: 375

Forging Machine Cam

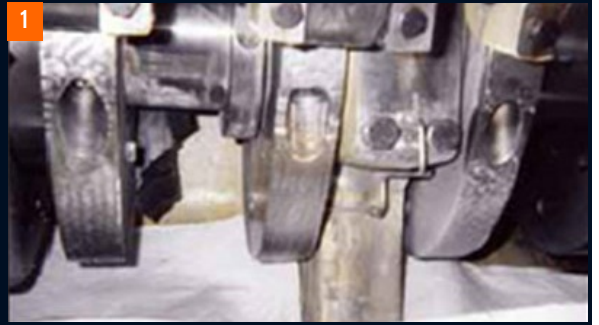
Forging machine cam failed, imitator product failed in one week.

1. The Cam
2. Products being used
3. The completed application

The application was carried out in accordance with a modified version of Belzona Know-How Systems Leaflet MPT-12. Damaged areas were ground down. Following degreasing, Belzona® 1111 was applied, then ground/sanded back to profile.
