# BELZONA REFORMS CLARIFIER SHAFT

ID: 3758

Vertical shaft of clarifier. 6 meters length and 20 centimetres diameter

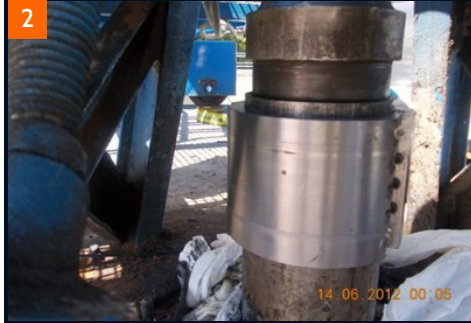
The damaged shaft had to be repaired but it could not be dismantled so an in-situ repair was required.

1. Shaft before application
2. Former in place
3. Injection of Belzona 1321 in progress
4. Rebuilt shaft

The application was carried out in accordance with the Belzona Know-How System Leaflet MPT-2. The shaft diameter was reformed using a pre-made former and injecting Belzona® 1321.
