# BELZONA TACKLES 98% SULFURIC ACID TANK

ID: 376

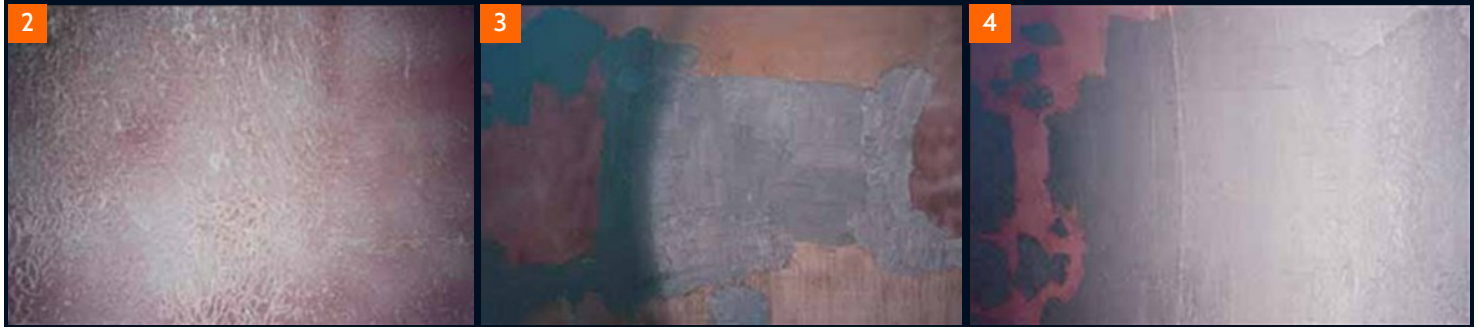
## PHOTOS

Tank coating had failed, leading to severe pitting.

1. & 2. Before

3. & 4. After

The application was carried out in accordance with Belzona Know-How Systems leaflet TCC-5. After the tank was neutralized, it was blasted to a near white metal finish.

Belzona 1111 (Super Metal)  
Belzona 4311 (Magma CR-1)
