# BELZONA INCREASES EFFICIENCY OF COOLING WATER PUMPS

ID: 3760

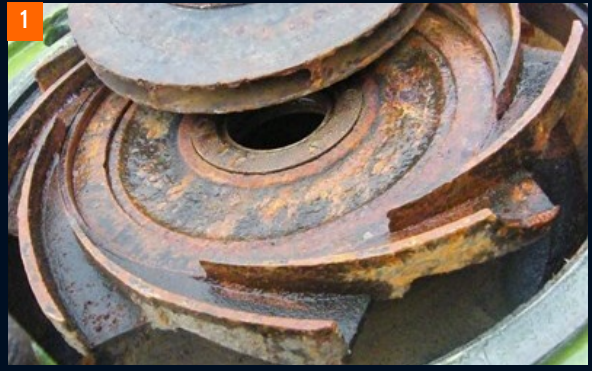
Traces of cavitation, corrosion damage as well as material loss found on the wetted surfaces of the pump. It was necessary to rebuild and coat the inlet, casing and suction cover with Belzona erosion-corrosion resistant products to restore efficiency.

1. Before application
2. After grit blasting
3. Rebuilt and coated pump
4. Finished application

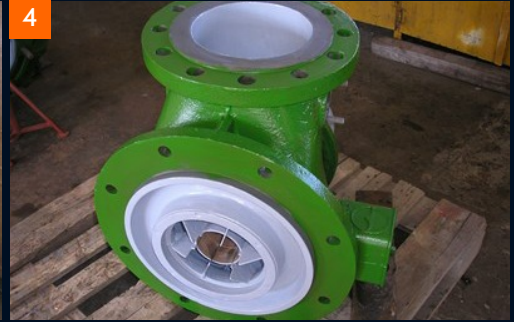
After installation the operating parameters of the pump were excellent; the power consumption reduced by 10-12%, from 270-280 amp prior repair to 240-250 amp. The operating pressure increased from the previous 8-8.5 bar to 9-9.5 bar and the flow rate increased from 400 m<sup>3</sup> to 450 m<sup>3</sup>. This means the repaired pumps performance corresponds to the manufacturer's original parameters.
