# BELZONA PROTECTS PLATFORM LEG ABOVE AND BELOW WATERLINE

ID: 3761

Offshore production platform leg

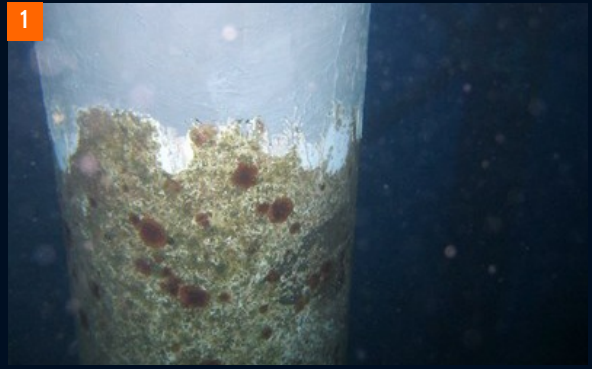
Due to constant immersion in seawater the platform leg in the splash zone was suffering from corrosion and needed protecting.

Damage before coating was applied  
1st coat of Belzona 5831 applied  
Completed application with 2nd coat of Belzona 5831 applied  
Excellent condition of coating when examined in 2012

Application was carried out in accordance with a modified version of Belzona Know-How System Leaflet SOS-21. After manually preparing the surface the Belzona® 5831 was applied in two coats to the corroded areas above and below the waterline. Application was completed by divers in the water.

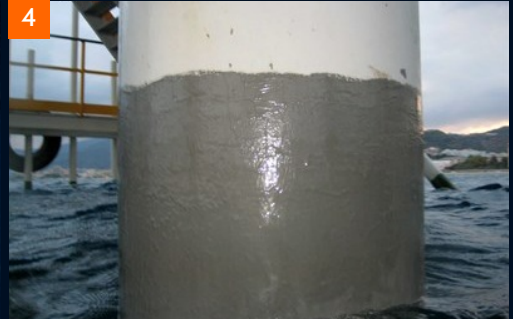
Belzona® 5831 has been developed as a surface tolerant coating for application to wet and underwater surfaces and is ideally suited to this type of repair where access for surface preparation and application is restricted. Inspected in 2012 the coating was still providing excellent corrosion protection.
