# BELZONA 4000 SERIES FLOOR COATING FOR A STERILIZING ROOM

ID: 378

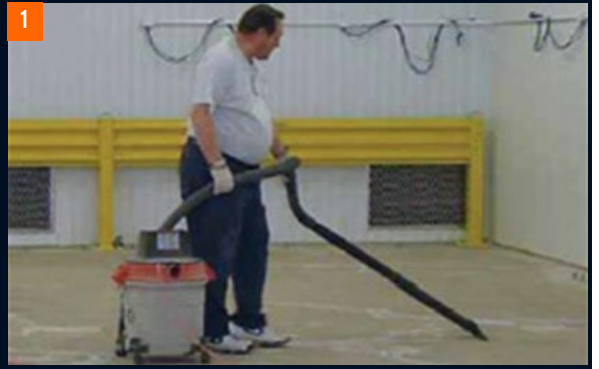
Floor was spalled, cracked and and therefore non-compliant with sanitary requirements.

1. Final steps of surface preparation
2. In progress
3. Job complete

The application was carried out in accordance with a modified version of Belzona Know-How System Leaflet FPA-3. Shot-blasted floor, followed by thorough cleaning. Roller/brush application of product in a slurry-grade.
