# BELZONA PROTECTION TO BUTANE TANK BASE

ID: 379

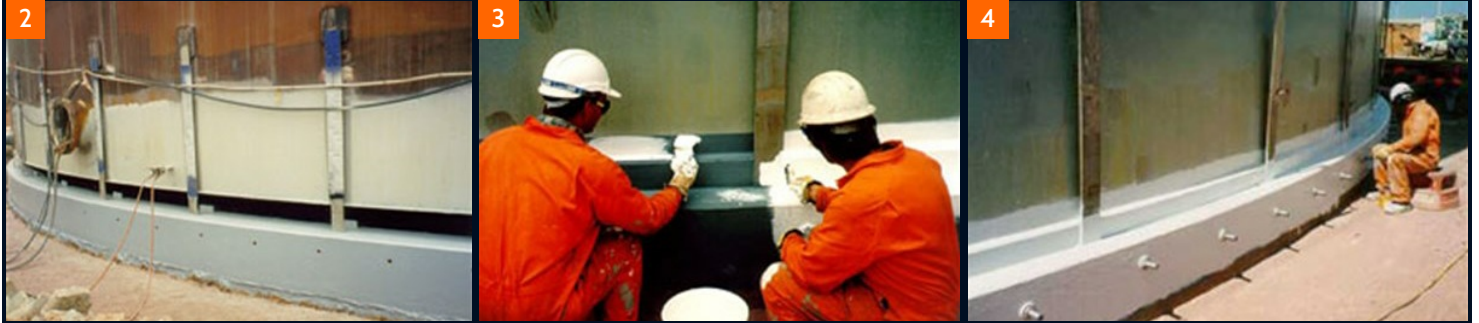
Corrosion at base of tank. At same time, timber supports were being renewed.

1. General view of the tank
2. Preparation of tank and base underway. Tank jacked up ready to install new timbers
3. Application underway
4. Application being completed

Belzona application creates a flexible, waterproof but microporous seal at junction of tank and base to provide long-term corrosion protection.
