# BELZONA FOUR YEARS ON COAL PIPES

ID: 38

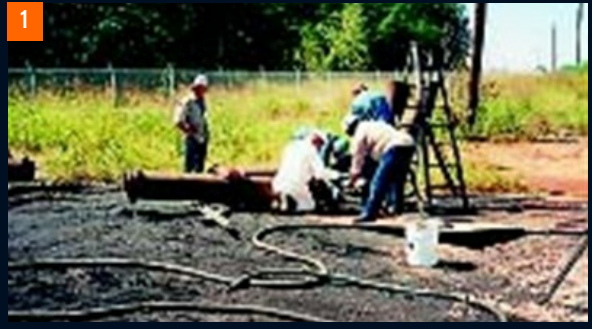
1. Grit blasting was used for surface preparation
2. Windows were cut to gain access to worn areas
3. Application of product

To gain access in the longest pipes, windows were cut opposite the worn areas. Product was applied and the windows welded together once installed. Rebuilt piping system lasted four years before it was replaced. \$1,000 of product extended the life of the piping system and saved the customer tens of thousands of dollars.
