# BELZONA REPAIRS 24" PIPE ELBOW

ID: 382

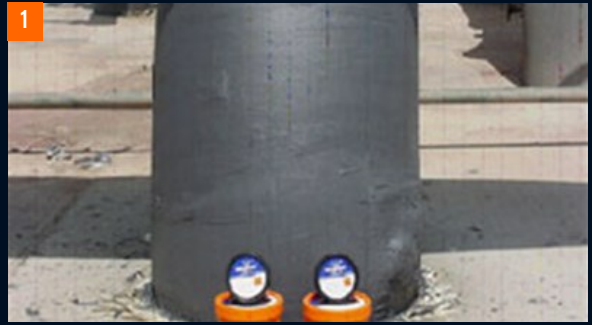
Failure of the internal lining had lead to wall thinning and a through wall defect. NDT was used to define the thinned area.

1. Front view
2. Side view
3. Test piece being prepared for evaluation

A steel patch was welded into position in the area of the through wall defect. A base layer of Belzona® 1311 was applied followed by Belzona® 9341. The whole process was then repeated and a layer of Belzona® 1311 applied to give a smooth finish.

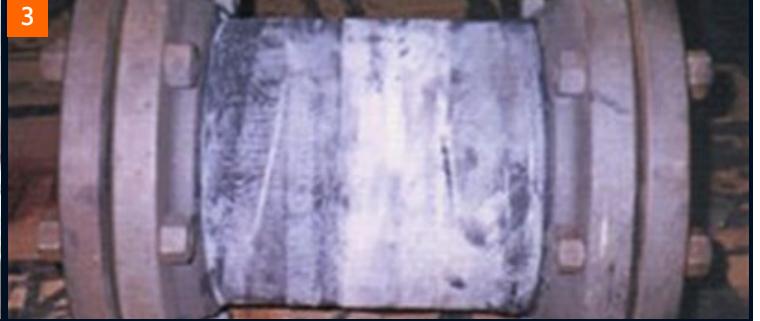
This repair was evaluated extensively by the maintenance team prior to being undertaken. Defects were ground into pipespools and the pipespools were then wrapped in the manner described above. These were then successfully pressure tested prior to undertaking the actual repairs.
