# BELZONA PROTECTS HEATED OIL STORAGE TANKS

ID: 384

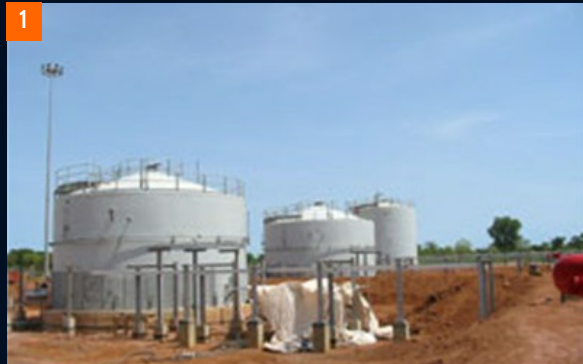
1. General view of the complex.
2. Heated airless spray equipment in operation.
3. Application of Belzona 1521 underway.
