# BELZONA PROTECTS OPEN DRAINS TANK

ID: 385

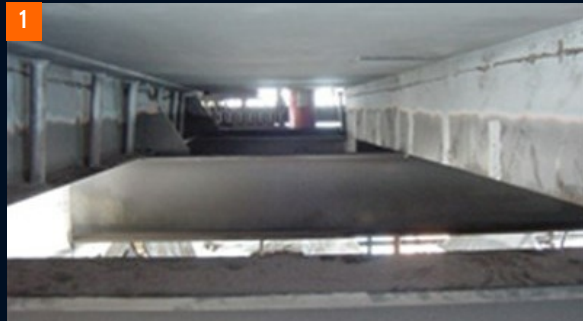
1. Front view showing Belzona product
2. Side view
3. Sealing of tank base seams using Belzona 1111

The tank base was grit blasted and plates were secured in position using Belzona® 1111 and held in place using chocks. Once the Belzona® 1111 had been allowed to cure, Belzona® 5811 was injected into the gap between the plate and the tank base. In addition all of the tank nozzles were wrapped using Belzona® 1111 / 9341 along with all of the tank base weld seams from the tank side/base joint. Following this the new tank base and sides were coated with Belzona® 6111 / 5111 for future corrosion protection.
