# BELZONA KEEPS THE BREAD DOUGH DRY

ID: 386

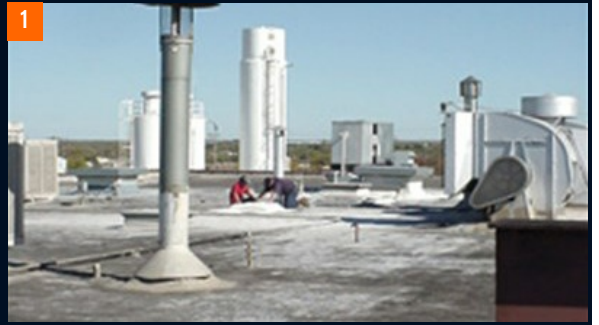
Sun, heat and age led to the roof coating becoming cracked and blistered in areas, allowing water to leak into the building.

1. View of roof with work in progress.
2. Close-up of blistered/cracked coating being sealed with the Belzona 3921 (GSC Conditioner) and Belzona 3111 (Flexible Membrane) System.
3. Roof problem area sealed.
4. Other problem areas were sealed.

Before proceeding with the application a test patch was done to a small leak over the general manager's office. The surface was roughened, Belzona® 3921 applied and a two-coat, fully reinforced Belzona® 3111 (Flexible Membrane) system installed. After three rainfalls and two months with no leaks, approval was given to address 500 square feet of problem areas. The coated areas of the roof are perfect.
