# BELZONA UPGRADES HOSPITAL ROOF

ID: 3866

## PROBLEM

This hospital roof required an insulation upgrade and in addition, weatherproofing to prevent any further damage.

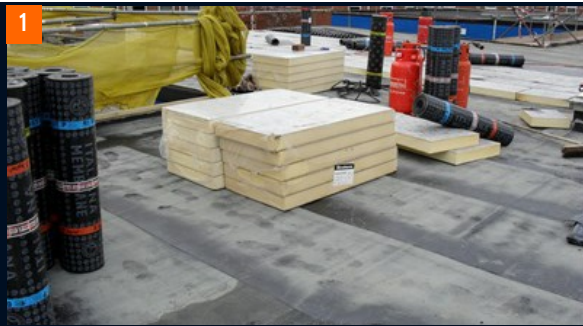
Large hospital roof which had deteriorated through weathering

1. Insulation boards ready for installation on the deteriorated roof
2. First coat of Belzona 3111 applied
3. Completed application

Application was carried out in accordance with Belzona Know-How System Leaflet RPA-8. After installing insulation boards overlayed with felt, a fully reinforced Belzona® 3111 system was applied.
