# SPALLED CONCRETE VAULTS ARE RECONSTRUCTED WITH BELZONA

Natural Gas Processing Plant in New Mexico, U.S.A.

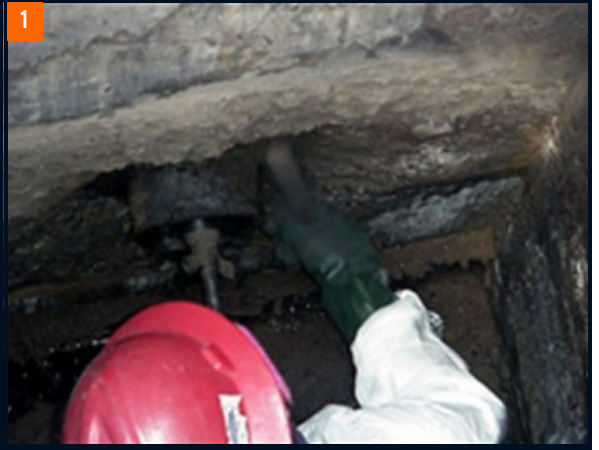
Over the years the different thermal expansion characteristics of the pipes caused the concrete surrounding pipes in the vault to spall.

1. Some of the spalls were 8 inches deep
2. Belzona 4911 applied, application of Belzona 4141 in progress
3. Admiring the reconstructed unit

The application was carried out in accordance with Belzona Know-How System Leaflet TCC-9.
