# BELZONA SAFETY GRIP SYSTEM ON STAIRS

ID: 3879

## PROBLEM

A potential slip hazard was identified on the metal stairs.

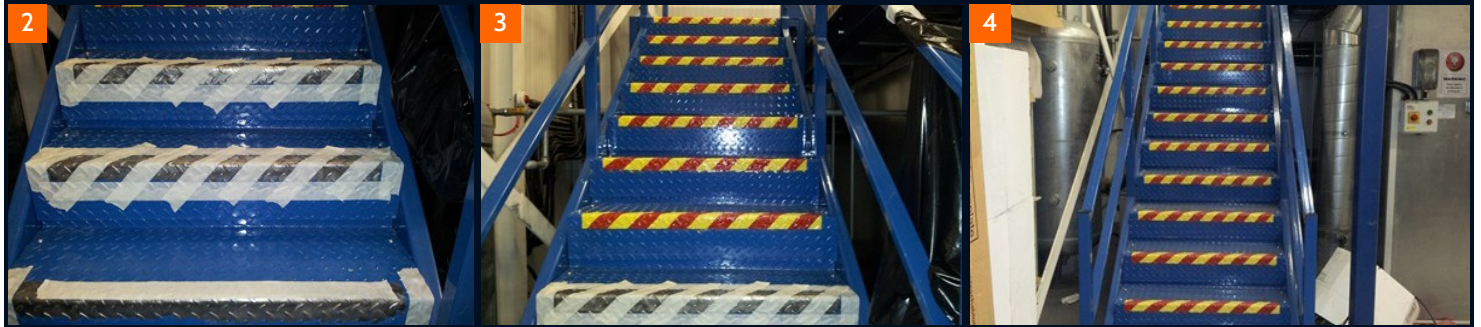
Metal stairs leading to a mezanine floor area.

1. Steps before Belzona Application
2. Abraded and Masked steps
3. Half of steps completed
4. Completed application

Application was carried out in accordance with Belzona Know-How System Leaflet FPA-8. After preparing the area with an MBX Bristle Blaster stripes of Belzona® 4411 red and yellow safety colours incorporating Belzona® 9221 aggregate were applied.

Belzona® 4411 gave a quick and easy solution to removing a slip hazard from a busy set of stairs. The non-slip properties of the Belzona Grip system are ideal for this dusty environment and safety colours aide in both identifying the step edges and in highlighting the potential hazard.
