# BELZONA RE-FORMS WARPED FLANGES FOR DECADES

ID: 388

Distorted flanges on heat exchanger.

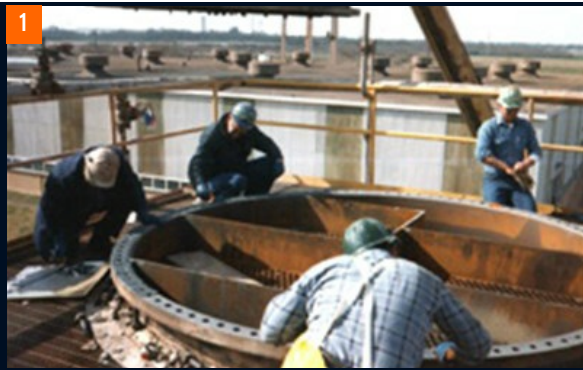
1. Application of Belzona 1111 in progress.
2. Upper head being hoisted into place to re-form the distorted flange.
3. After upper head was lowered excess material was removed prior to cure.
4. Flange face rebuilt.
