# BELZONA PROVIDES SOLUTION TO LEAKING HOSPITAL ROOF

ID: 3885

Felt roof over physiotherapy facility within the hospital.

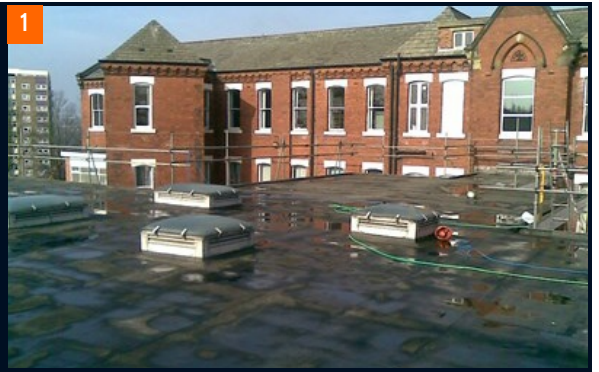
The felt roofing system had become porous over time and was allowing water into the building below. This was causing major disruption to the operation of the hospital as well as posing a health & safety risk.

1. Image of roof prior to application
2. Sealing around skylights and extraction unit
3. Completed application
