# REFURBISHMENT OF LARGE DIFFUSER PUMPS WITH BELZONA

ID: 3887

Two 48" cooling water circulating pumps

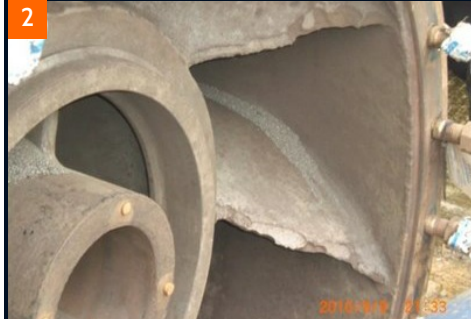
The pumps, each weighing over eleven tonnes without the motor, were failing to deliver sufficient flow to satisfy customer demand.

1. One of the diffuser pumps after disassembly
2. Degree of damage clearly evident on the diffuser vanes
3. Coated diffuser vanes
4. Coating of the pump internals and bell mouth with Belzona 1341 and Belzona 5811 externally
