# BELZONA PROTECTS PIPELINE FROM MILLSCALE WEAR

ID: 3890

500m long and 1.5m diameter Raw Water pipeline loaded with millscale.

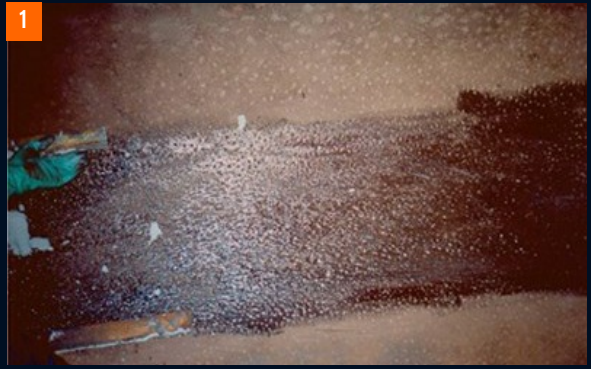
1. Application of Belzona 4911 after gritblasting the substrate
2. Beginning the application of Belzona 4111
3. Application in progress
4. Creating steps with Belzona 4111 on a sloping area of the pipeline, in order to facilitate the inspection

The application was carried out in accordance with Belzona Know-How System Leaflet VPF-2.
