# SLOPED SURFACE MADE SAFE WITH BELZONA

ID: 390

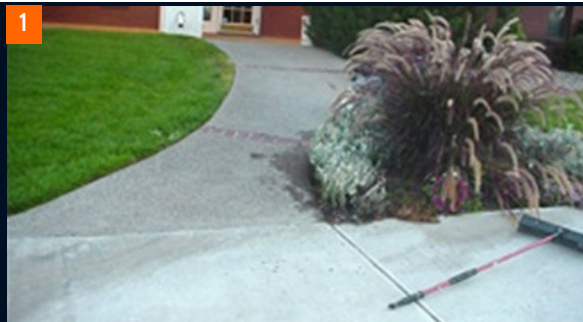
Sloped walkway with exposed aggregate became very slippery when wet, creating a safety hazard.

1. The slope walkway entrance was very slippery when wet.
2. The pattern is created as tape is being laid.
3. Application of the Belzona Non-Slip System in progress.
4. The finished non-slip system; the pedestrian area is made safe.

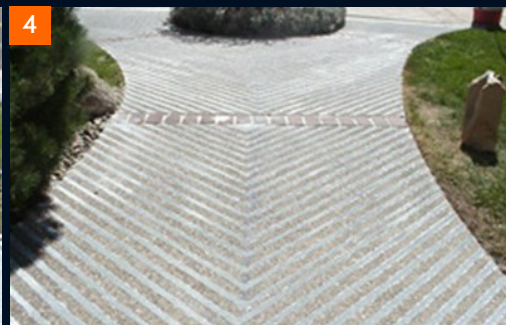
The non-slip system remains in perfect condition after several years. The potential for slippage is alleviated.
