# SERVICE LIFE EXTENDED: FLYING ASH IS NO PROBLEM FOR BELZONA

ID: 391

Fly ash fan moves fly ash from a lower hopper into one at an upper level of the plant.

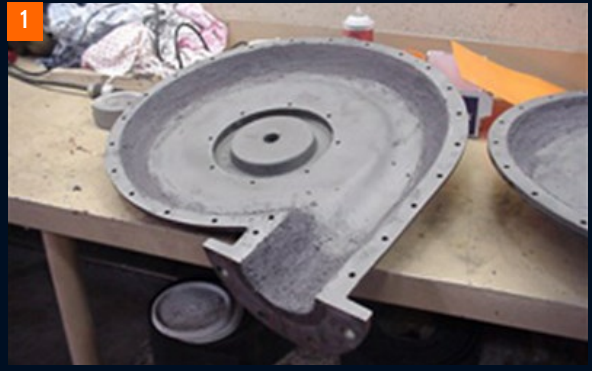
Severe wear

1. Worn fan casing damaged from abrasive particles is rebuilt and protected with Belzona 1812.
2. Fan impeller is coated with Belzona 2121.
3. The crew is happy with their work.

The fan impeller had a life expectancy of 3 months and costs \$1,300. The housing had a life expectancy of one year and costs \$3,000. After one year of service following the Belzona application, the fan was opened up and inspected. The impeller was 90% perfect and the housing was 100% perfect. The impeller was re-coated in June 2003, the housing remains perfect. This application has saved the customer over \$15,000 in less than two years.
