# THE LIFE EXPECTANCY OF ANOTHER PUMP IS EXTENDED SIGNIFICANTLY WITH BELZONA

ID: 392

Coal Fired Power Plant in New Mexico, U.S.A.

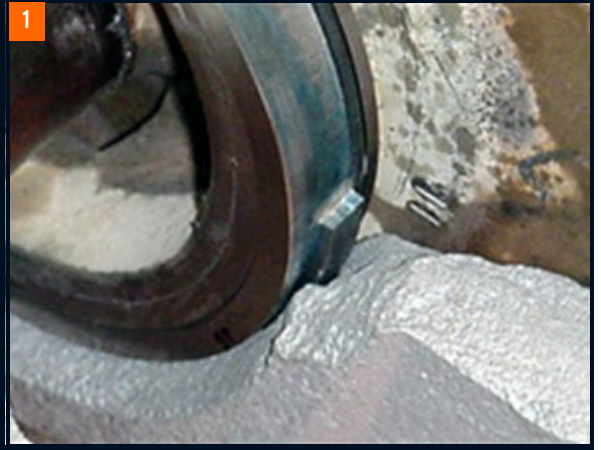
The pump was badly worn and the case ring landings were completely eroded.

1. Severe erosion of the case ring landings
2. Application in progress
3. Casing wear ring seats rebuilt
4. The pump casing is completely refurbished
