# BELZONA RENEWS DAMAGED LINING

Fiberglass tank used to store spent sulfuric acid.

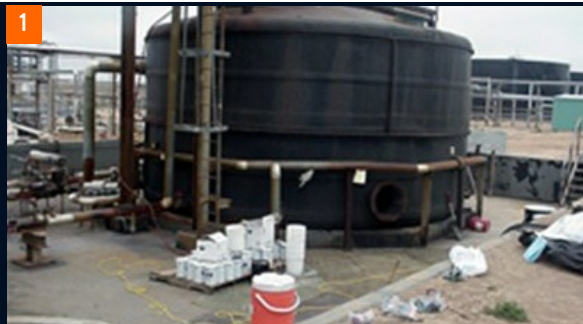
1. Outside view of the sulfuric acid holding tank
2. Close-up view of the FRP substrate
3. Application of the first coat commences
4. The second coat is applied

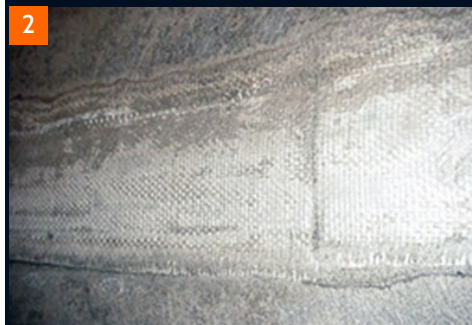
Dilute sulfuric acid eventually attacked the fiberglass surface and had the gelcoat completely eaten away in sections. The first layer of cloth was exposed in 50% of the internal tank surface.

All exposed glass fiber ends were shaved off. The internal tank surface was blasted and coated with two coats of Belzona® 5811. In August 2003, the refinery reported it had experienced perfect performance with coating.
