# BELZONA CRUDE OIL TRANSFER HOSE REPAIR

ID: 395

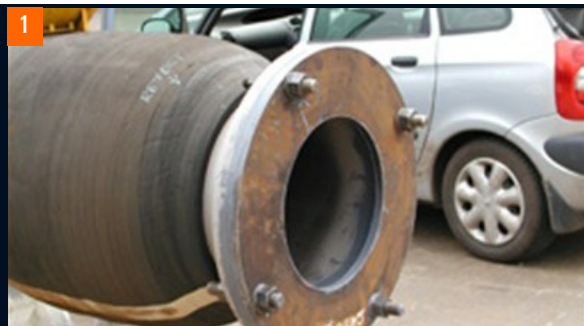
The sealing face of the transfer hose flange had been damaged preventing a seal.

1. Former in place and tightened up.
2. The end result shows a perfectly reproduced gramophone sealing face.
3. The hose was then pressure tested to 18 bar according to International (OCIMF 1991) and Dunlop Oil & Marine Test Guidelines.

The galvanising was grit-blasted off and a new sealing face formed using the Belzona® 1321. Rubber plugs were inserted to prevent excess material seeping in to the boltholes. Metal shims were inserted to ensure an adequate thickness of Belzona® 1321 was formed on the flange face.
