# BELZONA UPGRADES SAFETY AND APPEARANCE OF SCHOOL ENTRANCE

ID: 3973

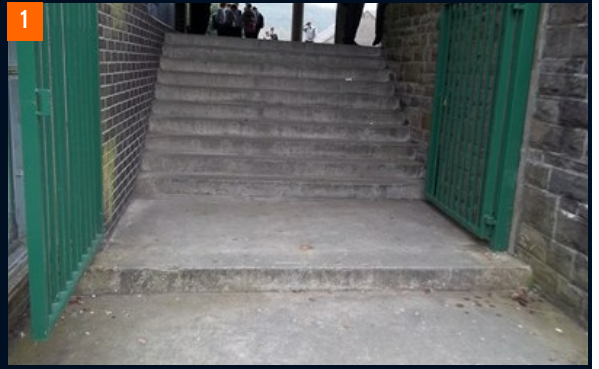
Step nosings had become damaged and overall very dirty. The school wanted the main entrance upgrading and wanted to ensure the steps were safe for its staff, pupils and visitors.

1. Deteriorating steps at the entrance to the school
2. Repair to steps using Belzona 4111
3. Application of Belzona 5231 overall
4. Complete repair with Belzona 4411 grip system applied to the step nosings.

Application was carried out in accordance with Belzona System Leaflets FPA-1 and FPA-8. The concrete step nosings were repaired using Belzona® 4111 before coating with Belzona® 5231. Finally a Belzona® 4411 grip system was applied to step nosings.
