# SCHOOL BUILDING RESTORED WITH BELZONA

School building suffering for the effects of the weather

Comprehensive School, South Wales

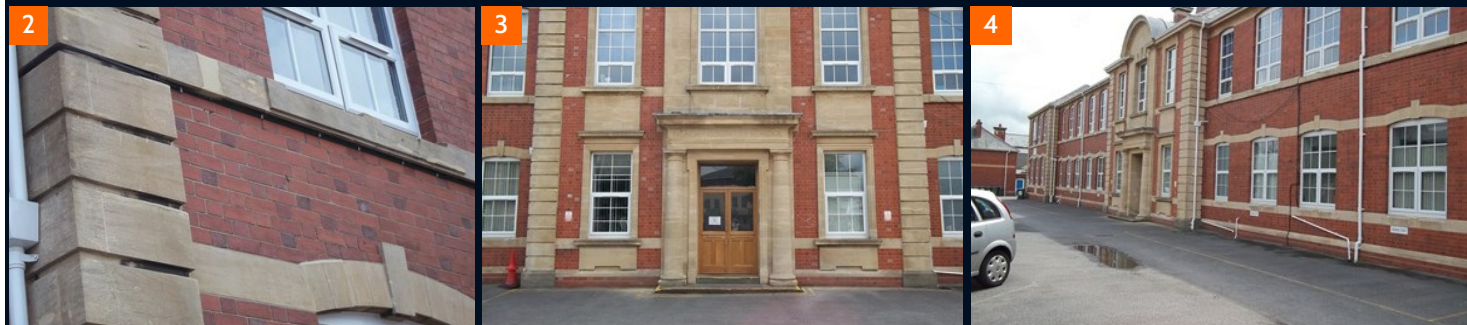
The stone work was weathering and the brick work was dirty. In addition there were areas suffering from rainwater ingress.

1. Front of the school with damaged areas of concrete
2. Damaged areas repaired with Belzona 4141
3. Application of Belzona 5122
4. Completed application

Application was carried out in accordance with Belzona System Leaflets WPA-4 & 8. The Belzona 4141 was tinted with a cement tone additive to colour match the repair with the Bath Stone and to ensure a visually pleasing repair. The final stage of the application was to overcoat the surface with Belzona 5122.
