# BELZONA ELASTOMER REPAIR TO SEVERELY DAMAGED HOSE

ID: 398

Holes, cuts and tears in the rubber covers of five floating pipes.

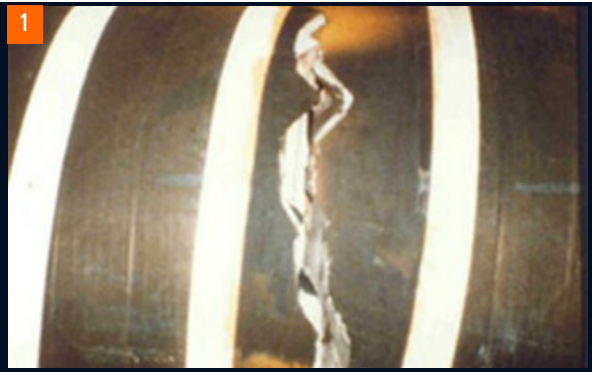
1. Typical tear in rubber pipe.
2. Application of Belzona 2111.
3. Floating pipe in service with neoprene patch bonded with Belzona 2111.
