# ROUTINE REPAIR OF FLOATING HOSES WITH BELZONA

ID: 399

Oil transfer hoses operating between single buoy moorings and tankers.

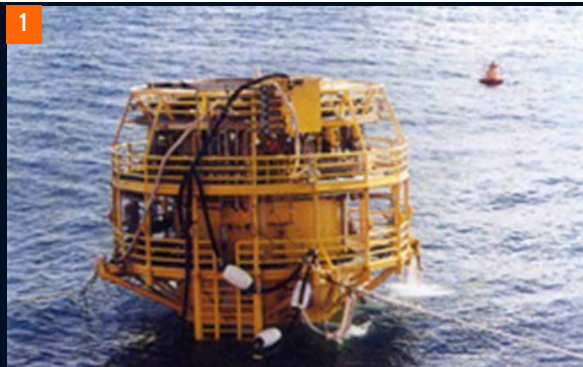
1. Typical single buoy mooring system.
2. Repaired damage to surface of the hose.
3. Completed applications.
