# BELZONA INSIDE A GEAR BOX

Gear box for pulper tub reducer.

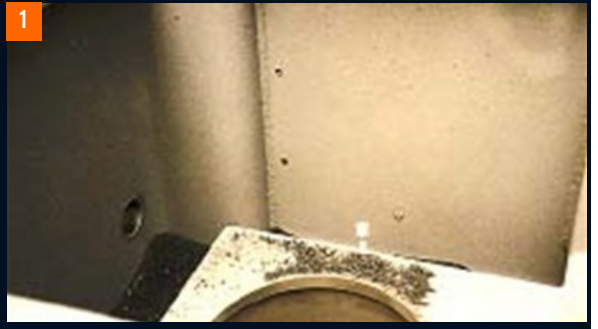
1. Internal surface of gear box grit blasted for surface preparation.
2. Inside coated with Belzona 1341 (Supermetalglide).
3. The lid of the gear box was also coated.

The application was carried out in accordance with a modified version of Belzona Know-How Leaflet CEP-3.
